A HYDROGEN-AIR EXPLOSION IN A PROCESS PLANT: A CASE HISTORY

Bjerketvedt, D and Mjaavatten, A

ABSTRACT

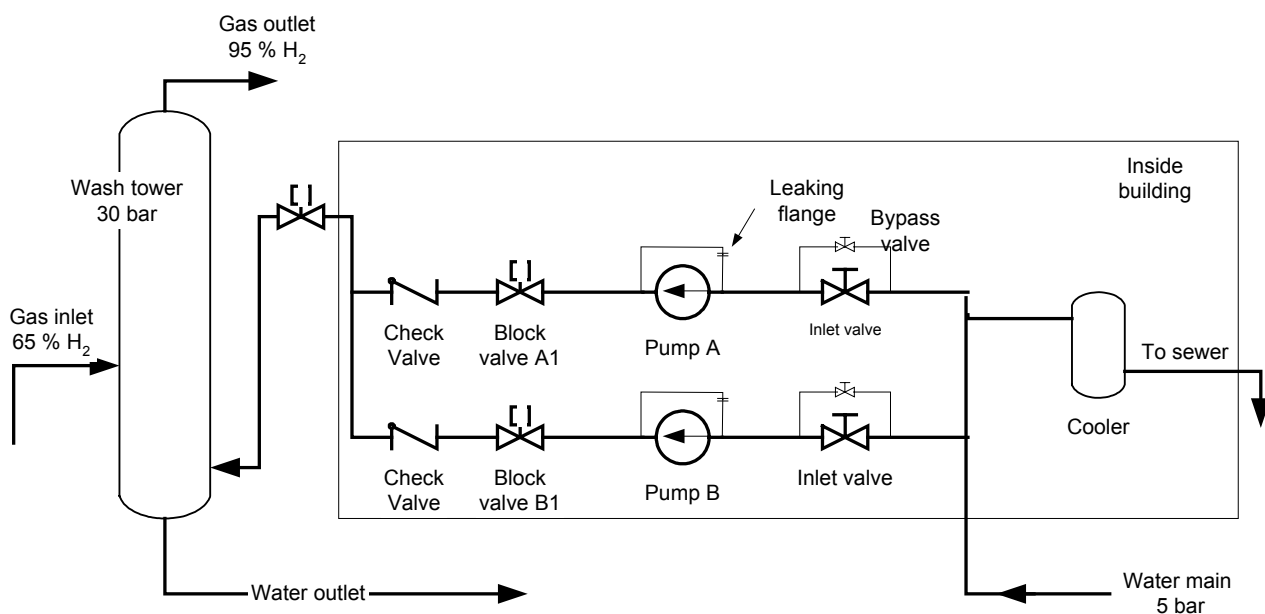
In the ammonia plant hydrogen was produced by partial oxidation of a heavy hydrocarbon fuel. The main explosion took place in the purification section of the hydrogen plant. This section contained a wash tower where CO₂ was being removed from the H₂ by absorption in water. A simplified process diagram is shown in Fig. 1. The hydrogen concentration in the gas feed to the absorption tower was typically 65% (vol). The

The accident occurred when operators were trying to change over from pump B to pump A. Unfortunately they did not observe that the inlet valve on the low-pressure side of pump A was closed. Only the small bypass valve was open. When pump B was stopped, the water supply from pump A was too low to maintain the water level in the absorption tower, resulting in an automatic shut down. A second attempt to start pump A resulted in a higher vibration level than normal for the pump. The operators discovered that the inlet valve was closed. They tried to open the valve, but failed because of the large pressure difference over the valve. Then bluish smoke was observed coming from the pump bearing, which had turned red-hot. At the same moment, water started to leak from a flange between the pump and the closed inlet valve. Pump A was then stopped. Normally the interlock system should then have closed valve block valve A1. However, this valve failed in 40% open position. Since the back flow was relatively low the check valve did not close. The water leak lasted for about 3 minutes before hydrogen gas from the tower reached the leaking gasket. Hydrogen was discharged into the building for 20 to 30 seconds before the explosion occurred.

Figure 1. Simplified process diagram

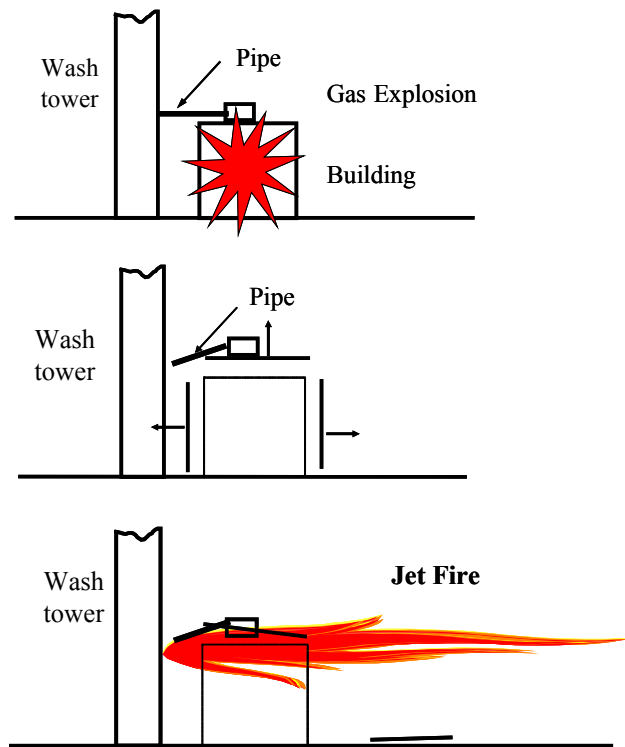
Figure 2. The explosion inside the building lifted the roof and a 350 mm diameter pipe was sheared off and large quantities of hydrogen leaked out and burned as jet flame

When the roof lifted and the 350 mm diameter tube broke off, we got a violent jet flame. Assuming the gas contained 65 % hydrogen (rest mostly CO₂) we estimated the maximum release rate of hydrogen to 20 to 30 kg/s. The leak lasted for 30 sec before the reservoir was emptied. For a free jet flame we estimated the flame length to be about 150 m. However the building construction acted as a flame holder and reduced the flame length. From burn marks we believe the actual flame length was 50 m.

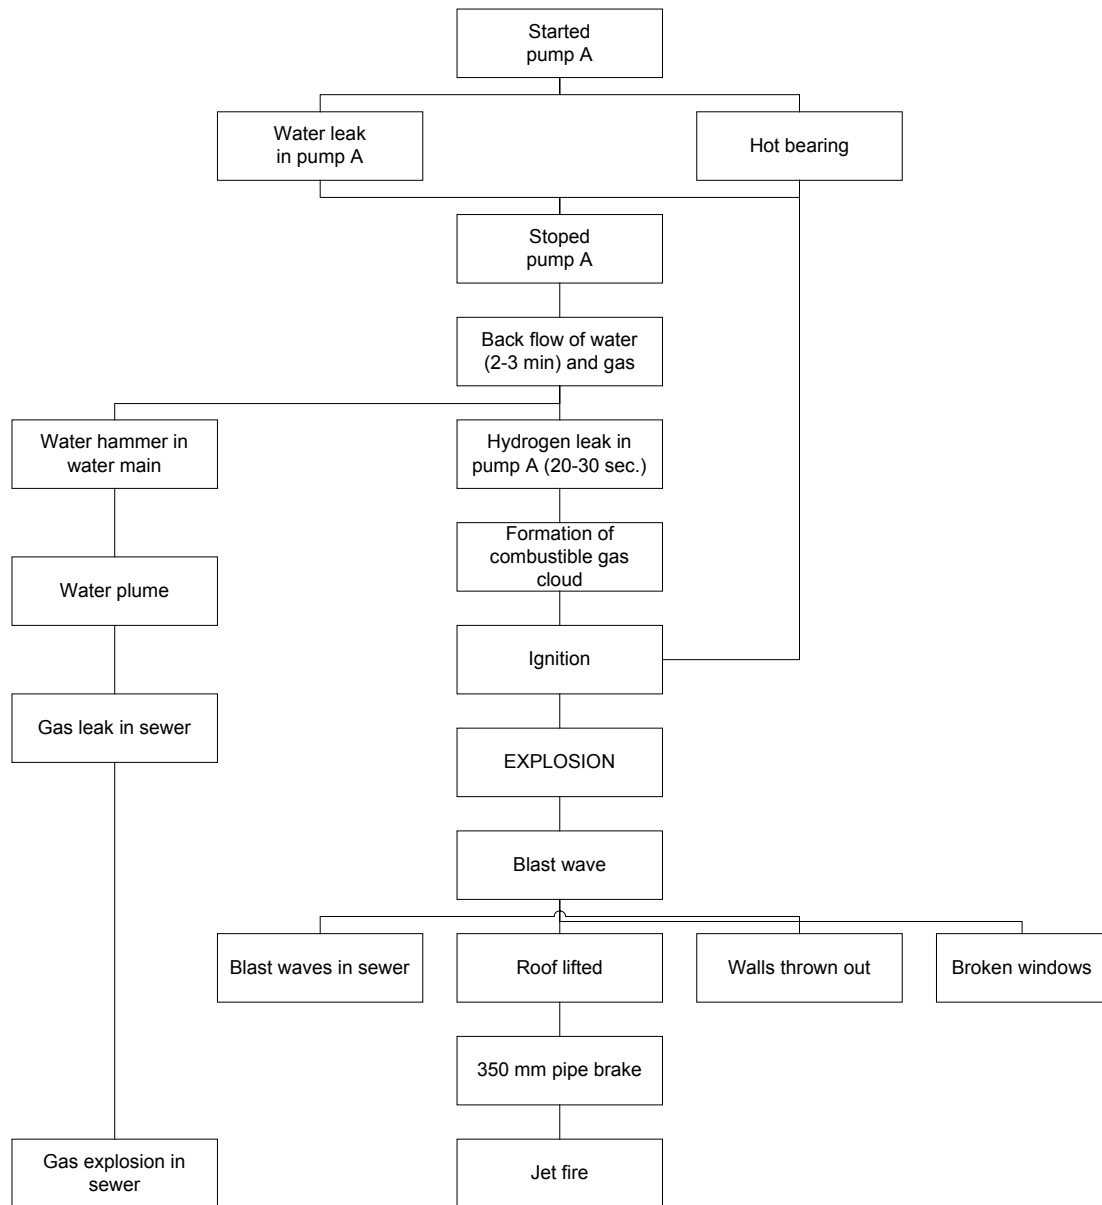
the cloud detonated (i.e. the flame was a supersonic combustion wave). From the damage it is clear that explosion pressures inside the building must have reached at least the order of 10 bars. 60 meters of the sidewalls were blown out and the roof was lifted up more than one meter. As the roof lifted, it tore off a 350 mm diameter pipe coming from the wash tower. This new release resulted in a jet fire with an initial flame length of 50 meters lasting for approximately 30 sec. Hydrogen also leaked also through the small bypass valve into the sewer system. Explosions in the sewer system then followed. Fig. 3 shows the coarse of events.

Figure 3. Course of events

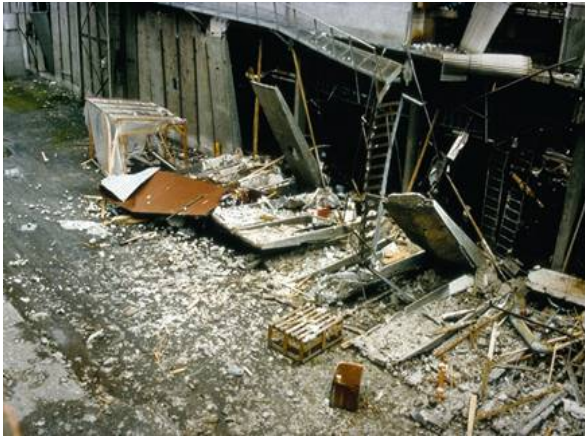
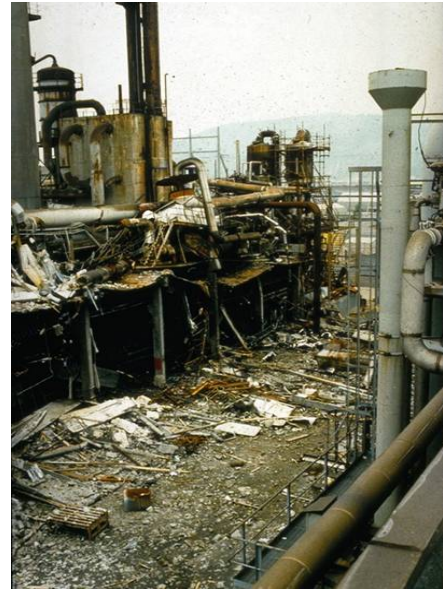
The north wall consisted of prefabricated concrete wall elements. These elements were 1.45 m wide and 7 m high. The lower part of the element was a solid concrete block acting as a “foot”. We estimated the weight of the wall and the foot to 1.2 and 2.0 metric tons, respectively. The total weight of a wall element was thus 3.2 tons. As shown in Figs. 2 and 4 these wall elements were thrown out and heavily damaged over a distance of nearly 30 m. Four of the elements were thrown 12 to 16 m out from its original position. We used the RCM code [2] to calculate the impulsive load the wall elements were subjected to. We used both constant volume combustion and detonation pressure profiles as input for these calculations. The calculations show that the impulse is proportional to the mass of hydrogen taking part in the explosion and that for rapid combustion the impulse is almost independent of the combustion time. The results are shown in Table 1. Taking account of the displacement of the wall in the calculations had no significant effect on the calculated impulse.

We used a highly simplified model to study the trajectory of the wall elements: We assumed that the impulse from the pressure loading was transferred to the wall without significantly deforming it, and that the “foot” mass had an initial velocity of zero. If we disregard all forces on the wall except gravity, it is straightforward to calculate the angular velocity of the wall and the trajectory of the centre of mass. The resulting motion is indicated in Fig. 5. The figure neatly explains the somewhat confusing fact that the wall fragments were found with their inside down. As shown in Table 1 both the 7 kg and the 14 kg cases yield results that are consistent with observations, whereas it is more difficult to reconcile the 3.5 kg case with the observed position of the wall fragments.

Figure 4 a and b. The wall element of the north wall thrown out

Three of the four wall elements that were thrown out were located next to each other. The fourth was 3 m from the three others. Damage inside the building indicated that strong local explosions (i.e. high pressure zone) had occurred in four distinct areas.

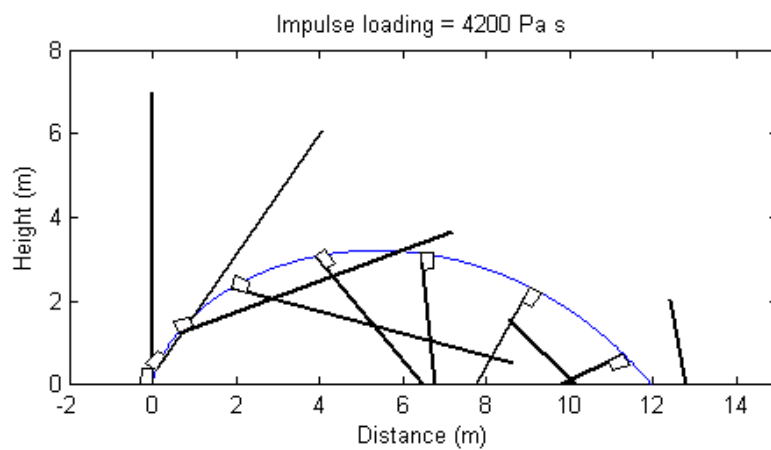
Figure 5. Trajectory of a wall element from the north wall

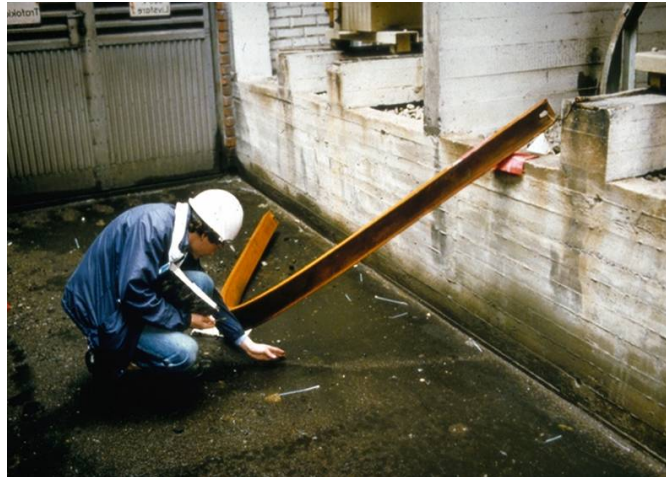
The south wall was a brick wall with steel beams. About 60 m of this wall was destroyed. According to Harris [3] the natural frequency and failure pressure for such brick walls are 20 to 40 ms and 0.07 to 0.15 bar. If we take dynamic loading into account and assume a spherical expanding blast wave we found that 3.5 to 7 kg of H₂ was required to cause this damage.

Figure 6. A fragment from the south wall landed 50 m away

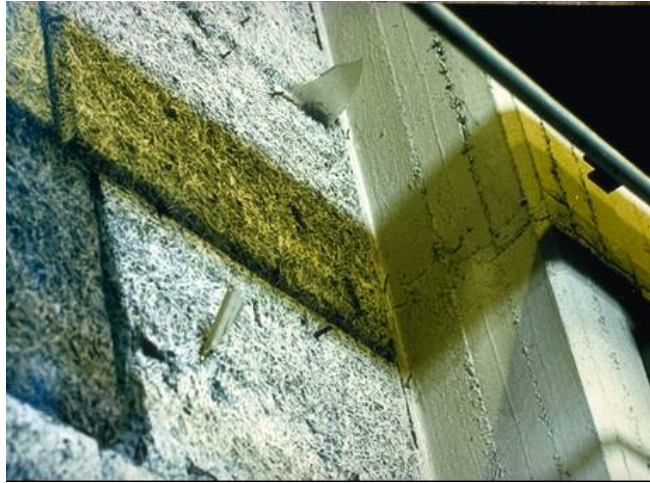
The neighbouring building on the north side had a large window section facing the explosion area. The glass thickness was 6 mm. This window section shattered and glass fragments had hit the wall on the opposite side. This wall consisted of building plates made out of wood shaving and concrete. As shown in Fig. 7 the glass fragments penetrated into this rather strong wall material. From the impact pattern we estimated the initial velocity of the fragments to 25 m/s, consistent with a reflected pressure of 0.9 bar.

Figure 7. Glass fragments penetrated into a wall

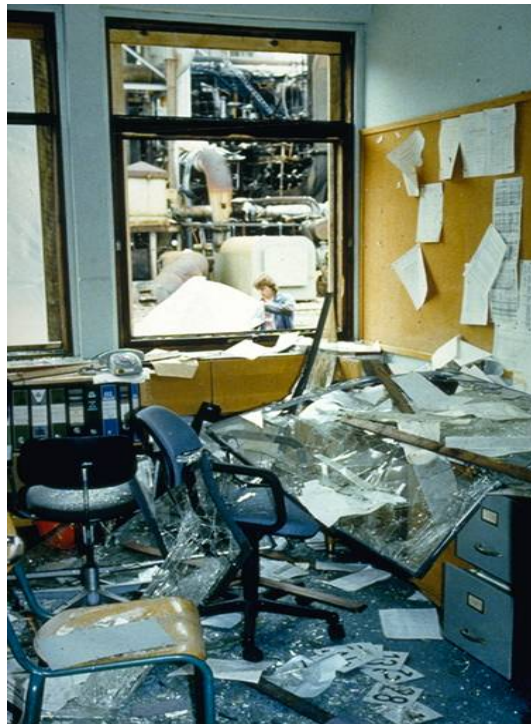
The control room building containing offices was located about 50 m to the south of the explosion centre. One of the office windows had a blast resistant glass and a solid frame. This window was not damaged. An adhesive plastic film protected the window glass in another office. This window was blown in as shown in Fig 8. Although the plastic film did not save the window it kept most fragments together, potentially reducing the severity of injuries somewhat.

Figure 8. Glass window with plastic film

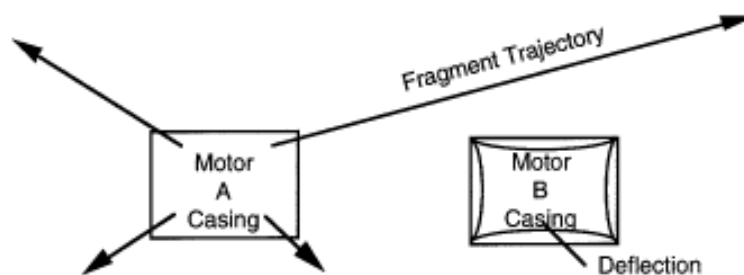
Figure 9. Casing of motor A and B

In the present accident the ignition source was almost certainly the hot bearing. From the damage to the motor A casing we know that the cloud was ignited in the area of the hot bearing. As shown in Fig 9 the four sections of the casing was found up to 15 m from their original position. It is evident that hydrogen must

have intruded into motor A and that the flame in an early phase of the explosion propagated under the casing and blew away the four sections.
