DYNAMIC CRUSH TEST ON HYDROGEN PRESSURIZED CYLINDER

Hiroyuki Mitsuishi¹, Koichi Oshino², Shogo Watanabe²

¹ Japan Automobile Research Institute, Takaheta1328-23, Shirosato, Ibaraki, 311-4316, Japan

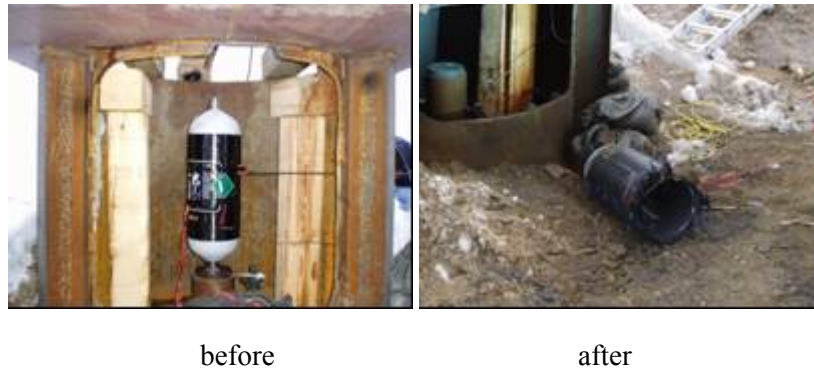
Figure 3. Cylinder situation (T-2: Type-3a, Axial, Disp. 88 mm, 35 MPa).

The cylinder fixed in position before the test, was ruptured at the border of the body and dome sections of the cylinder after the test. It was thrown out of the test apparatus by the impact. The force-displacement curve from the test is shown in Fig. 4.

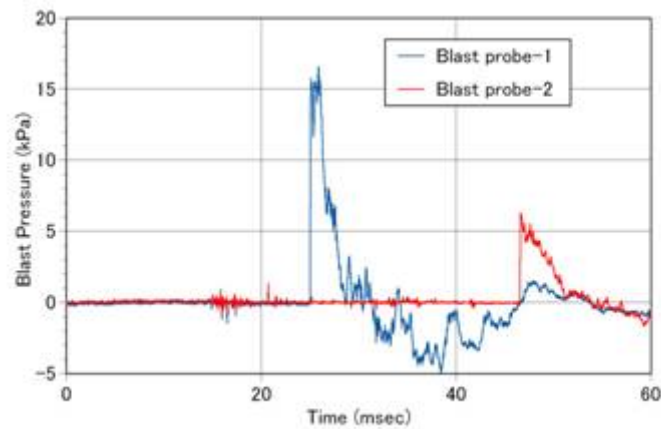
Figure 5. Blast pressure – time curve (T-2: Type-3a, Axial, Disp. 88 mm, 35 MPa).

The pressure of probe 1 located at a point 5.5 m from the tank was a maximum of around 15 kPa. From the distances of probes 1 and 2 and the time when pressure waves were measured, it was determined that the pressure waves spread in the vicinity at approximately the velocity of sound.

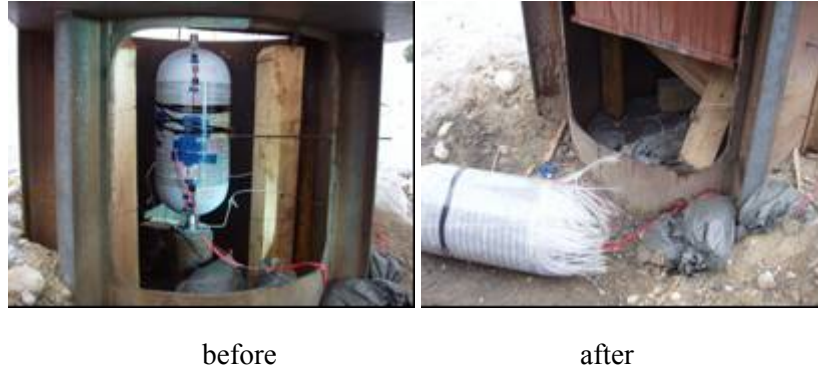
Figure 9 shows the condition before and after test T-12 (cylinder: Type-3b, filling pressure: 35 MPa, load morphology: axial compression, displacement magnitude: 100 mm), which used the same type of cylinder (Type-3: aluminum alloy with full wrap liner) as in the previous tests, but has different specifications such as the thickness of the aluminum liner. A Type-3a cylinder ruptured under the same test conditions as in T-12.

Figure 9. Cylinder situation (T-12: Type-3b, Axial, Disp. 100 mm, 35 MPa).

Damage to the cylinder after the test was concentrated around the dome, but no ruptures were seen in the border area between the cylinder dome and body. The force-displacement curve is shown in Fig. 10. The load showed a maximum value of about 75 kN in the initial deformation at about 20 mm, and afterward decreased. However, no load increase was seen immediately before rupture (Fig. 4) as was seen in examples of rupture.

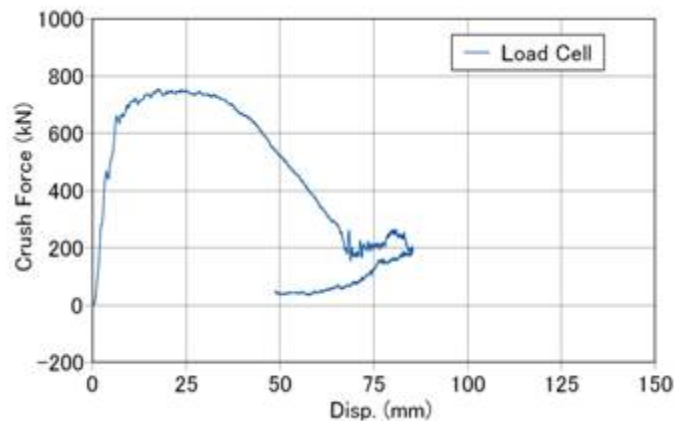
Figure 10. Force – displacement curve (T-12: Type-3b, Axial, Disp. 100 mm, 35 MPa).

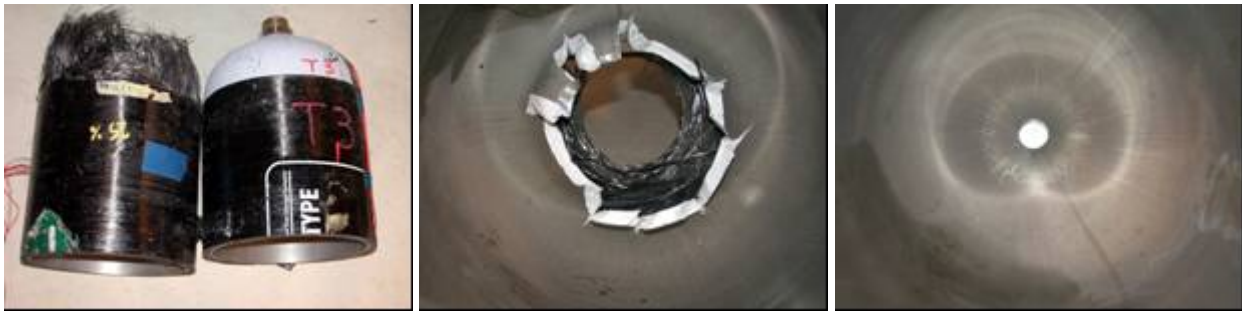
In tests in which the cylinder did not burst, damage was concentrated in the dome. Figure 12 shows the condition of the dome after test T-3, and Fig. 13 shows that after test T-12.

Exterior

Interior of bottom dome

Interior of top dome

Figure 12. Damage to cylinder in test T-3 (T-3: Type-3a, Axial, Disp. 138 mm, 7 MPa).

In cases when the cylinder did not burst, the area around the mouth ring of the aluminum liner was damaged, and gas leaked from the damaged portions. However, since the damage did not extend to the cylinder body, there was no large-scale emission of filling gas as a result of fracture in the cylinder body. Next, Fig. 14 shows the fracture surface of the fractured portion of the cylinder in test T-2, in which the cylinder ruptured.
