# **COMPATIBILITY OF MATERIALS WITH HYDROGEN PARTICULAR CASE: HYDROGEN ASSISTED STRESS CRACKING OF TITANIUM ALLOYS.**

**Azkarate, I. , Ezponda, E. and Madina, V.**  
**INASMET-Tecnalia, Mikeletegi Pasealekua 2, San Sebastian, 20009, Spain,**  
**iazkara@inasmets.es**

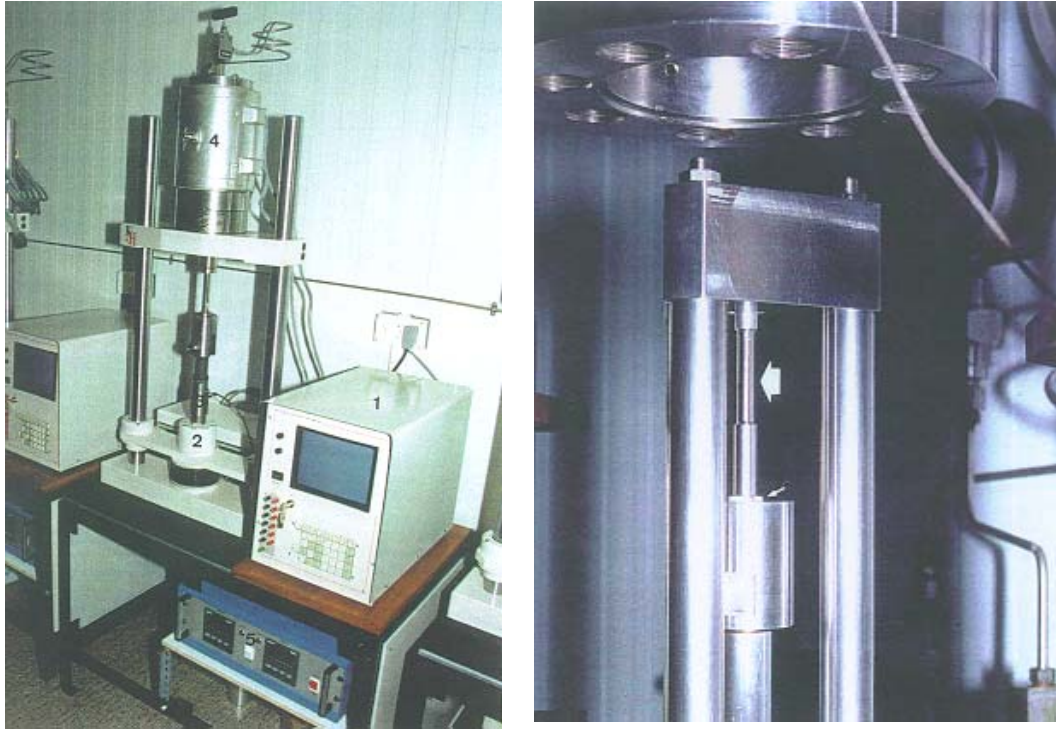
Figure 2. General view of the SSRT equipment. Detail of testing specimen in the autoclave.

Round tensile test specimens were located in Hastelloy C-276 autoclaves and attached to a fixed frame by one end and to the pull rod by the other.

Fittings made of  $ZrO_2$  were used to ensure the electrical insulation of the specimens from the autoclave (Figure 2).

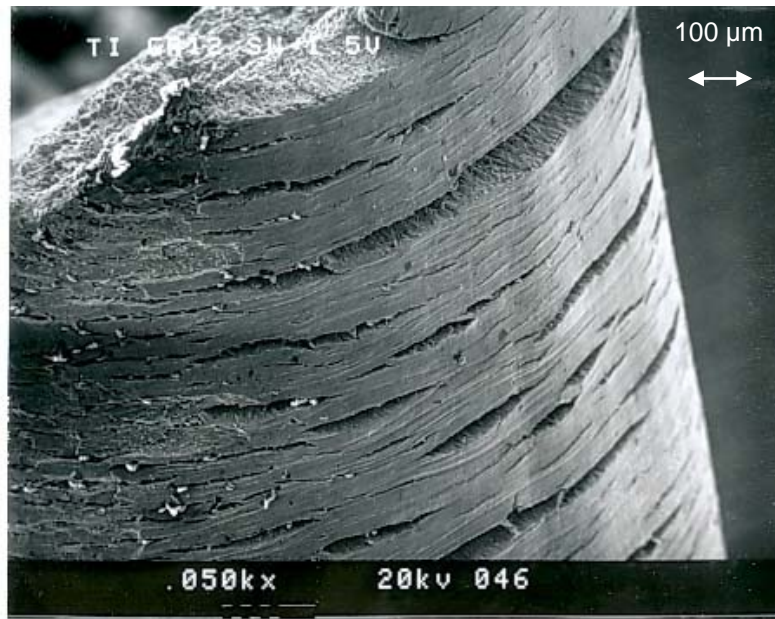
Figure 3. Secondary cracking on lateral surface of Ti Gr-12 specimen tested at a strain rate of  $2 \times 10^{-7} \text{ s}^{-1}$  in sea water with a cathodic polarization of -1500 mV (Ag/AgCl).

Load, position of the actuator, time and temperature data were continuously logged during the test by means of the microprocessor that controlled the testing machine. After each test, the elongation, reduction of area, energy, yield strength, maximum load, and true stress at fracture were the measured parameters to assess the loss of ductility and sensitivity of the studied materials to the HASC. This was complemented by metallographic studies performed by optical microscopy on probes prepared from longitudinal cuts of the tested specimens (Figures 4, 5 and 6), and fractographic studies of the fracture surface of the specimens by scanning electron microscopy (Figure 3).

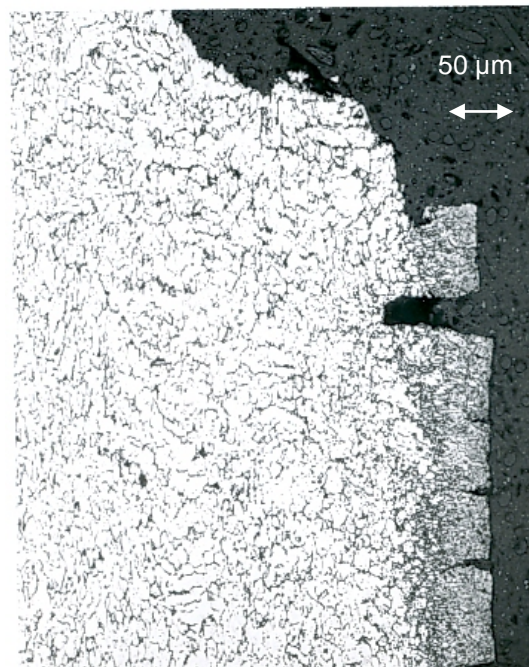
Figure 4. Hydride layer and secondary cracks on lateral surface of Ti Gr-12 specimen tested at a strain rate of  $2 \times 10^{-7} \text{ s}^{-1}$  in sea water with a cathodic polarization of -1500 mV (Ag/AgCl).

The thickness of the titanium hydride layer formed on the specimen surface when tested in the highest cathodic polarization condition, -1500 mV (Ag/AgCl), has resulted to be of up to 30  $\mu\text{m}$  for the Ti Gr-2 alloy, 120  $\mu\text{m}$  for the Ti Gr-12 alloy and has not been observed in the case of Ti Gr-5 alloy.
