# ASSESSMENT OF SAFETY FOR HYDROGEN FUEL CELL VEHICLE

## ABSTRACT

A prospective global market share of Electric vehicle (EV), Hybrid electric vehicle (HEV) and Hydrogen Fuel Cell Vehicle (HFCV) is expected to grow due to stringent emission regulation and oil depletion. However, it is essential to secure protection against high-pressure hydrogen gas and high-voltage in fuel cell vehicles and thus needs to develop a technique for safety assessment of HFCV.

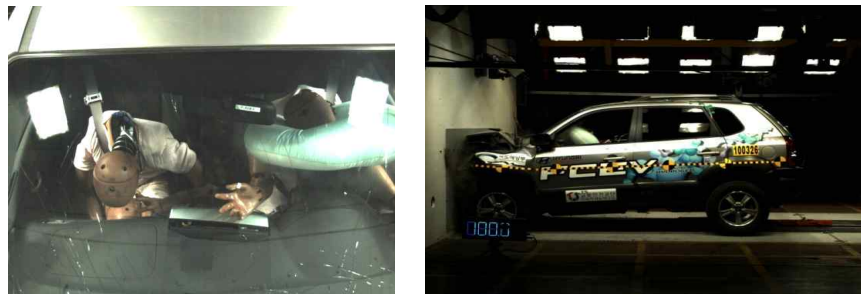
Pictures in Fig. 4 show the vehicle of frontal impact test scene. After the test, the occupant safety requirements met KMVSS article 91, 102.

Figure 4. The test vehicle of frontal impact test.

The high (31.5 MPa) and low (0.8 MPa) pressure stayed constant showing no reduction in pressure.

The largest deformation, 41.69 mm occurred along the longitudinal center line, which was measured the hydrogen receptacle points. In the area around the fuel tanks, brackets supporting the front fuel tank showed the largest damage, 41.38 mm.

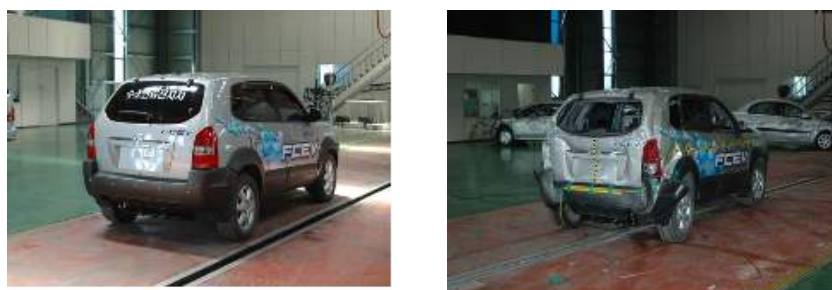
Pictures in Figure 5 show the vehicle before and after the test. Other than some weights to adjust the total weight of the vehicle, no additional system was installed in the engine compartment and the luggage compartment of the vehicle. After the test, the rearmost fuel tank was displaced toward the front by 172 mm, but not damaged.

Figure 5. Rear-right view of the test vehicle before and after test.

The high (33 MPa) and low (1 MPa) pressure stayed constant showing no reduction in pressure.

The largest deformation, 245 mm occurred along the longitudinal center line, which was measured between the mid points of front and rear bumpers. In the area around the fuel tanks, brackets supporting the rearmost fuel tank showed the largest damage, 172 mm.

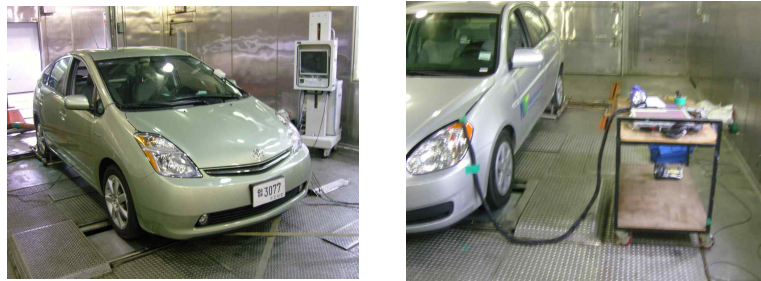
control the output of the device for cutting the production junction boxes, such as in Figure 9 are blocking the signals, a dedicated diagnostic equipment, using the measurement and analysis of test data. HEV analysis signals of junction box and ETAS INCA (ver. 5.4). EV analysis of the test data for a current meter of battery, measured with NI-PXI program developed using Labview.

Figure 9. Test vehicle and Data acquisition System

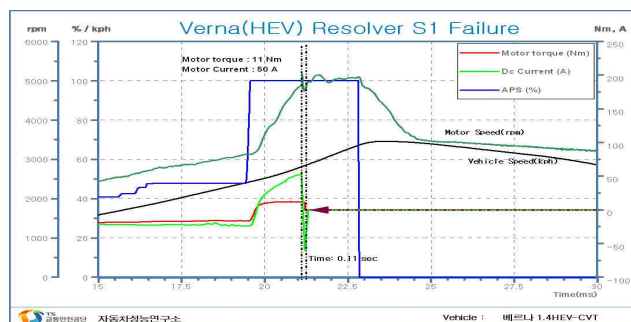
Figure 11 shows that return to idle immediately when the signal was cut the motor position sensor(Resolver) in the output state of 50A and 11Nm. When the rotor position sensor occur the failure, the torque of motor blocked and the vehicle driven by the output only engine.

Figure 11. Failure of resolver signal

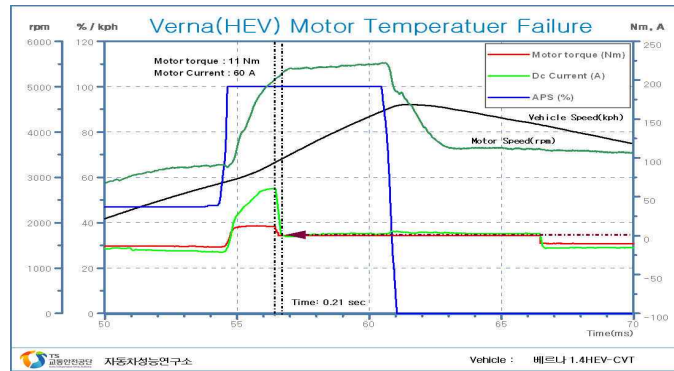
Figure 12. is a case of cutting phenomenon that motor temperature signal. Immediately after cutting, the motor power is shut off to return to idle. Failure of motor temperature sensor will work the control strategy to the system output is limited to 50%

Figure 12. Failure of motor temperature sensor

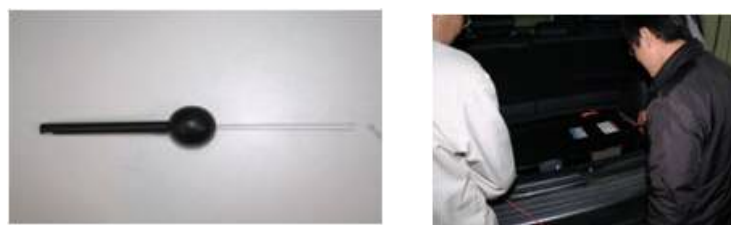
Using the IPXX D test finger, evaluation tests were carried out passenger compartment and supercapacity of luggage compartment.

Figure 14. IPXX D (test wire) and luggage evaluation.

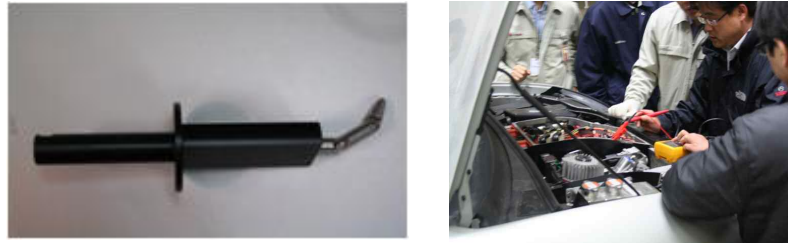
(2) The live parts in areas other than the passenger compartment or luggage compartment<sup>2),4)</sup>  
Using the IPXX B test finger, evaluation tests were carried out junction box of bonnet.

Figure 15. IPXX B (test wire) and bonnet evaluation.

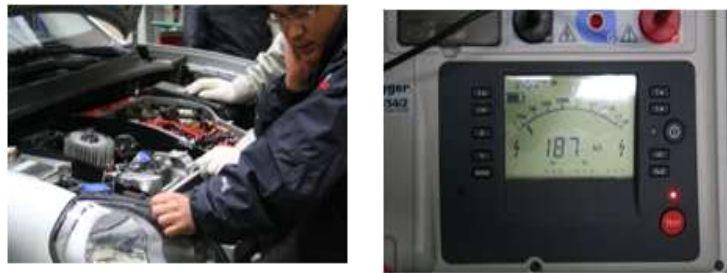
The minimum of electrical insulation resistance should be more than 100  $\Omega/V$  (DC), 500  $\Omega/V$ (AC).<sup>2),4)</sup> Insulation resistance of AC and DC input and output with both the vehicle chassis was evaluated above 1.28 k $\Omega/V$

Figure 16. Insulation resistance evaluation.

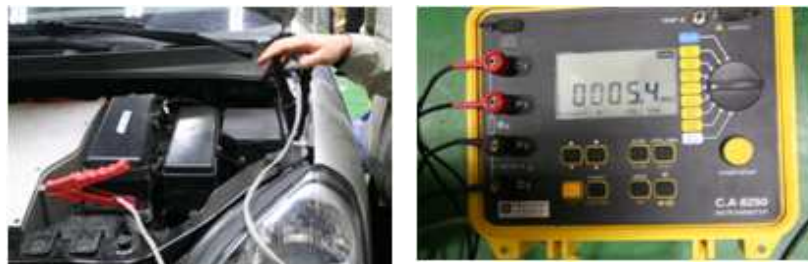
The test criteria of Protection against indirect contact should be less than 100 m $\Omega$ .<sup>2),4)</sup> The high voltage box enclosure and the Chassis was evaluated 5.4 m $\Omega$ . The supercapacitor enclosure and the chassis was evaluated 45.4 m $\Omega$ .

Figure 17. The high voltage box enclosure and the chassis evaluation.

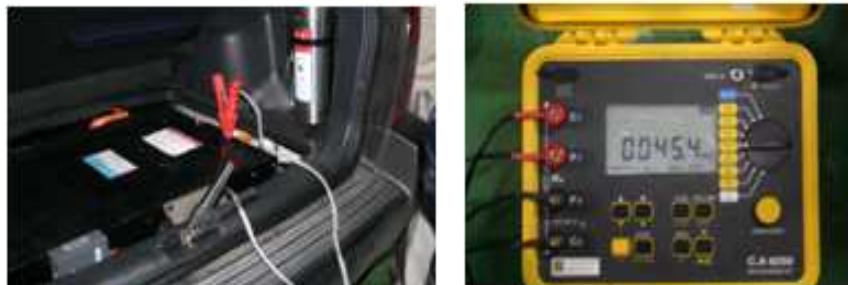
Figure 18. The supercapacitor enclosure and the chassis evaluation.
