DISPERSION AND BURNING BEHAVIOR OF HYDROGEN RELEASED IN A FULL-SCALE RESIDENTIAL GARAGE IN THE PRESENCE AND ABSENCE OF CONVENTIONAL AUTOMOBILES

ABSTRACT

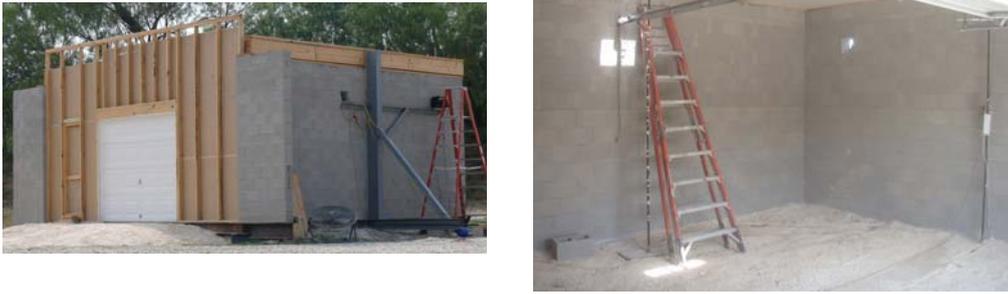
Figure 1. Exterior and interior view of garage facility

The enclosure was built to have some resistance to the overpressures expected when a large hydrogen/air mixture is ignited, while having characteristics similar to a typical residential garage. The two side and back walls were constructed by stacking (mortar was not used) interlaced rows of 19.4 cm (w) × 38.8 cm (l) × 19.4 cm (h) cinder blocks on top of a foundation formed from steel I-beams. Lengths of 19 mm diameter steel reinforcing bar spaced on 81.3 cm centers were welded to the steel foundation and passed upwards through openings in the cinder blocks to the top of the walls. Vertical openings in the blocks spaced every 20.3 cm were filled with concrete. Additional strength was provided by 114.3 cm wide exterior perpendicular block sidewalls built at the open sides of the block structure. Wall reinforcement was provided by exterior heavy steel I-beam support buttresses placed at the centers of the three walls and corners at the rear.

Two 0.2 m × 0.2 m openings in the right side wall at heights of 2.3 m provided visual access to the interior. Interior lighting was provided by two 0.3 m × 0.3 m ceiling skylights located over the vertical sensor array (see ahead) and center of the ceiling. The four openings were covered with poly(methyl methacrylate) (PMMA) sheets. The interior ceiling was covered by 1.3 cm thick gypsum wallboard. The garage floor was formed by filling the enclosed steel I-beam foundation volume with leveled packed soil. Potential leaks, such as those between the cinder blocks and where the ceiling and front wall met the block walls, were sealed with caulking and/or duct tape. The degree of sealing varied as the tests progressed. Fig. 1 shows exterior and interior photographs of the garage.

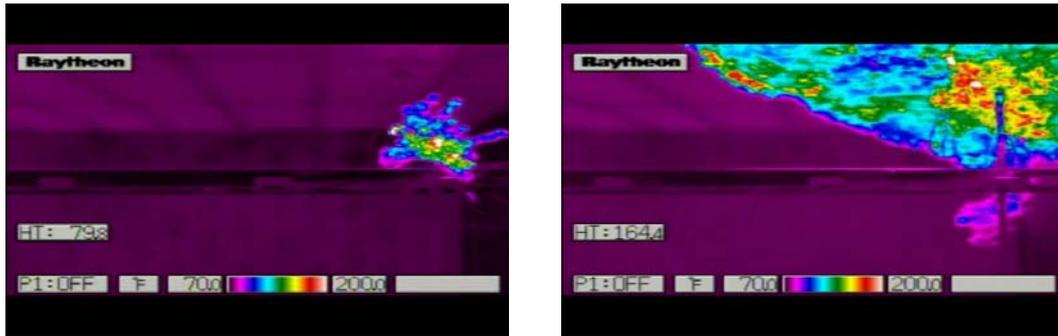
Figure 4. Two frames taken from an infrared video show the flame 90 ms (left) and 1.7 s (right) after the squib fired in a 6.6 % hydrogen/air mixture.

Ignition was achieved using 80 J squib charges. Videos showed these devices expelled small burning fragments that ignited the hydrogen/air mixtures along their trajectories. Nonetheless, after combustion became established, a well-defined flame front moved away from the ignition location. Fig. 4 shows infrared views from a video of a flame shortly after squib firing and after the flame had begun propagating near the ceiling to the left in a 6.6 % hydrogen/air mixture. By using similar infrared images or ionization gauge signals, flame front positions as a function of time were measured

Interesting phenomena were observed for flames ignited with hydrogen concentrations around 8 %. In the infrared video from which the frames in Fig. 4 were taken, a weak flame front was observed near

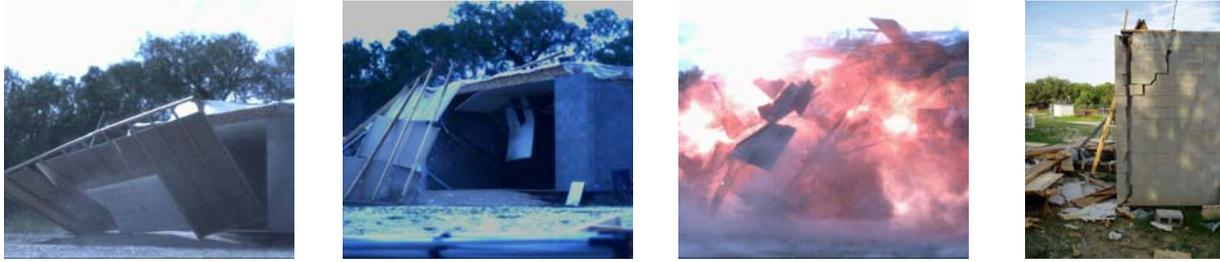
Figure 6. Three frames from high-speed videos showing the effects of igniting hydrogen/air mixtures having volume fractions of 13.3 %, 15.2 %, and 29.3 %. The photograph at right shows block-wall damage due to ignition of the 29.3 % hydrogen mixture.

When the hydrogen concentration at the ignition location was increased to around 12 % the overpressure generated by the combustion was sufficient to blow the front wall away from the enclosure, as can be seen in the frame on the left side of Fig. 6. There was no apparent lifting of the roof, and the interior gypsum wallboard ceiling was not dislodged. For ignition of hydrogen concentrations around 16 % the combustion became more vigorous, and the resulting overpressures caused additional building damage. The second frame in Fig. 6 shows a test in which a 15.2 % hydrogen/air mixture was ignited. The resulting overpressure dislodged the front wall and propelled it several meters away. In the video, it was evident that the roof also moved upward several cm before settling back down. Several whole sheets of gypsum wallboard were dislodged from the ceiling, suggesting that combustion occurred in the space between the wallboard and the plywood roof.

By far, the largest explosion and most extensive structural damage were observed for the test in which the 29.3 % hydrogen/air mixture was ignited. The third panel in Fig. 6 shows a frame from the high-speed video. The front wall, garage door, and roof have been shattered and are moving away from the block walls at high rates. Most of the roof disappeared from view, before falling to earth over three second later. Portions of the front wall were propelled tens of meters from the site. Unlike the tests with ignition at lower hydrogen levels, orange flames are clearly visible, providing an indication of the higher flame temperatures present for this condition. The block walls remained standing after the test, but as can be seen in the photograph at the right of Fig. 6, large cracks developed through the blocks, and inspection revealed that the force of the explosion had sheared off the internal reinforcing steel rods at the wall base and had shifted the walls several centimeters on the foundation.

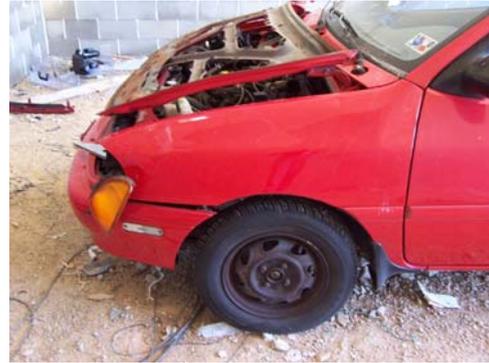
Figure 8. Frame from HD video showing moment of hydrogen ignition in engine compartment of 1996 Ford Aspire (left) and resulting vehicle damage (right).

The evidence indicates that the spreading flame outside of the 1996 Ford Aspire ultimately ignited the higher concentration hydrogen trapped underneath the vehicle (measured to be 27 % at the top of the engine, see upper-right panel of Fig. 3). This was confirmed by an interior HD video which showed that ignition first occurred at the rear of vehicle and rapidly spread underneath the vehicle to the engine compartment (≈ 0.1 s), where it created an intense, visible flame. The left side of Fig. 8 shows a frame from the interior video at the instance the engine compartment ignited. The right side is a photograph of the vehicle after the test. In addition to the hood being blown off, the body was bulging, the hubcaps were blown off, and much of the trim was damaged. The resulting increase in overpressure also shattered the PMMA protecting the interior camera, broke one of the skylight coverings, and brought down two sheets of ceiling gypsum wallboard. This damage was more severe than observed for similar hydrogen concentrations when a vehicle was not present.

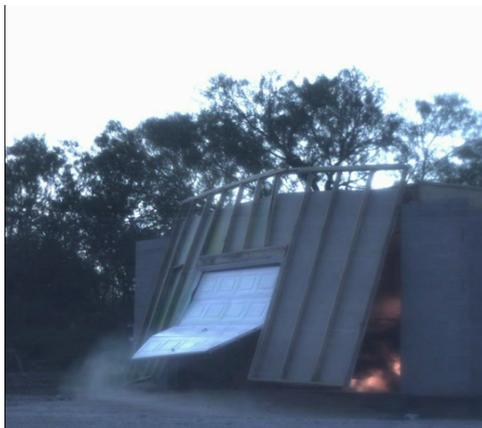
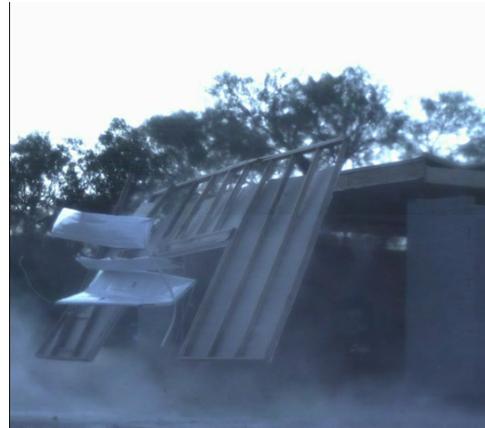
Figure 9. Two frames from a high-speed video recorded approximately 0.5 s and 0.6 s following ignition with a hydrogen concentration of 15.7 % in a garage containing a 1995 BMW 325i.

The combustion behavior for a case where a 15.7 % hydrogen/air mixture was ignited in the presence of a 1995 BMW 325i was similar to that for the 11.4 % experiment with a vehicle, but more intense. Following ignition, there was a short period when the combustion behavior was similar to those tests with comparable hydrogen concentrations at the ignition location without an automobile present, but after 0.5 s higher hydrogen concentrations inside the vehicle ignited near the front end and caused a considerably more vigorous event. Fig. 9 shows two frames from a high-speed video taken from outside of the garage. In the left panel the overpressure inside the garage has started to push the front wall outwards. The ignition of the hydrogen trapped in the vehicle had occurred a few milliseconds earlier, and flames are visible on and in the vehicle. Overpressures were substantially increased, and the garage door was blown apart and the front wall was accelerated and shattered (right panel). The entire roof was lifted. Following the test, parts of the front wall were found tens of meters from the garage. The roof settled back down on the block walls, but sustained considerable damage. Most of

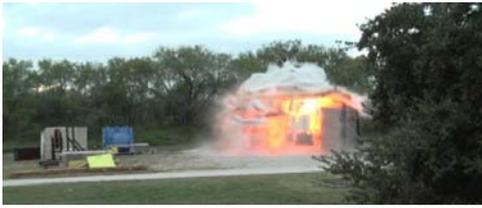
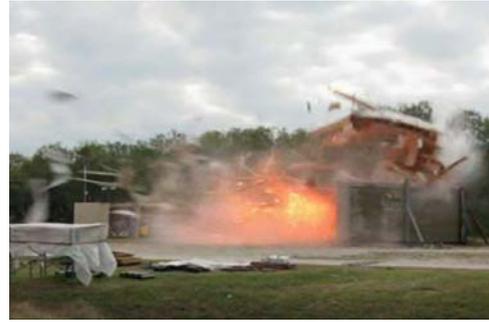
Figure 10. Frames from front- (left) and side-view (right) videos of a test where an 18.6 % hydrogen/air mixture was ignited with a 1995 Ford Explorer located in the garage.

The final test was ignited at a hydrogen concentration of 18.6 % with a 1995 Ford Explorer in the garage. This was a much larger vehicle than used in the earlier tests. The garage was completely destroyed. Fig. 10 shows views of the explosion from two DV video cameras. Flames are visible. The front wall has been shattered, and the roof has been blown off and is falling apart. There was a 0.15 s period between when the garage first began to respond to the ignition and when the intense orange flames suddenly appeared. Fig. 11 shows differential pressure traces from the sidewall transducer over two time periods. The first is similar to that shown in Fig. 7 for ignition of a 15.6 % hydrogen mixture with no vehicle present. It represents the overpressure generated by the initial flame spread. The second curve developed when the higher concentration hydrogen trapped in the vehicle ignited. The delay between the two curves is consistent with the time derived from the videos. The overpressures increased substantially and became highly variable with time. Pressure magnitudes were similar to those recorded (Fig. 7) when a 29.3 % hydrogen/air mixture was ignited without an automobile present. Recall that the garage was also destroyed during this test.

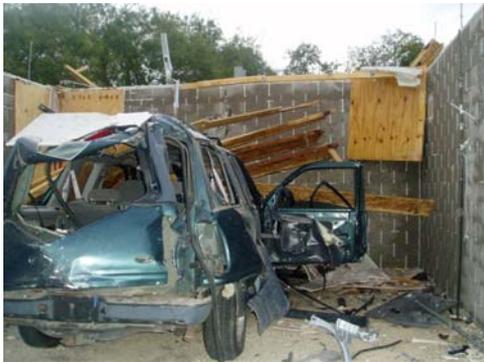
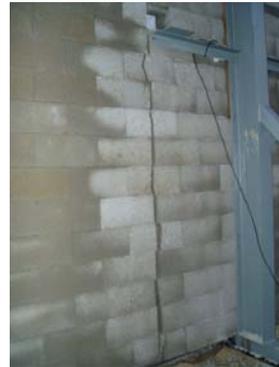
Figure 12. Photographs of the garage interior and vehicle (left) and exterior block wall damage (right) following ignition of 18.6 % hydrogen/air mixture

The Ford Explorer was heavily damaged during the test as can be seen in Fig. 12. As seen in the test when 29.3 % hydrogen was ignited without a vehicle present, the overpressure generated during the test resulted in the formation of long cracks in the block walls. An example is shown in Fig. 12. Examination showed that the block walls were also shifted on their foundation as observed earlier.
