THE SPREAD OF FIRE FROM ADJOINING VEHICLES TO A HYDROGEN FUEL CELL VEHICLE

Tamura, Y.¹, Takabayashi, M.¹, Takeuchi, M.¹ and Mitsuishi, H.¹

¹ FC-EV Research Division, Japan Automobile Research Institute,

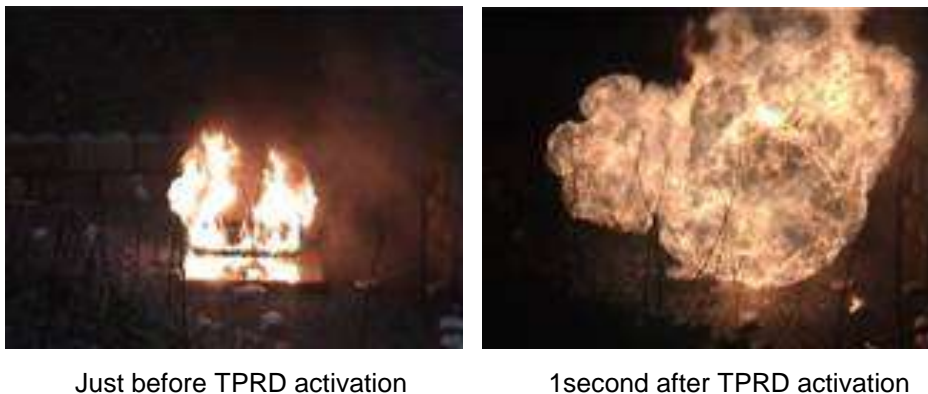
On the other hand, while HFCV are placed on the market, there are possibilities of HFCV as well as other types of vehicles catching fire in vehicle collisions and natural disasters (e.g. earthquakes) or by arsonists. For example, in the case of a HFCV fire is caused by a gasoline pool fire, when the TPRD is activated, a fireball more than 10m diameter formed¹, as shown in Figure 1.

Figure 1. a HFCV fire test is caused by a gasoline pool fire

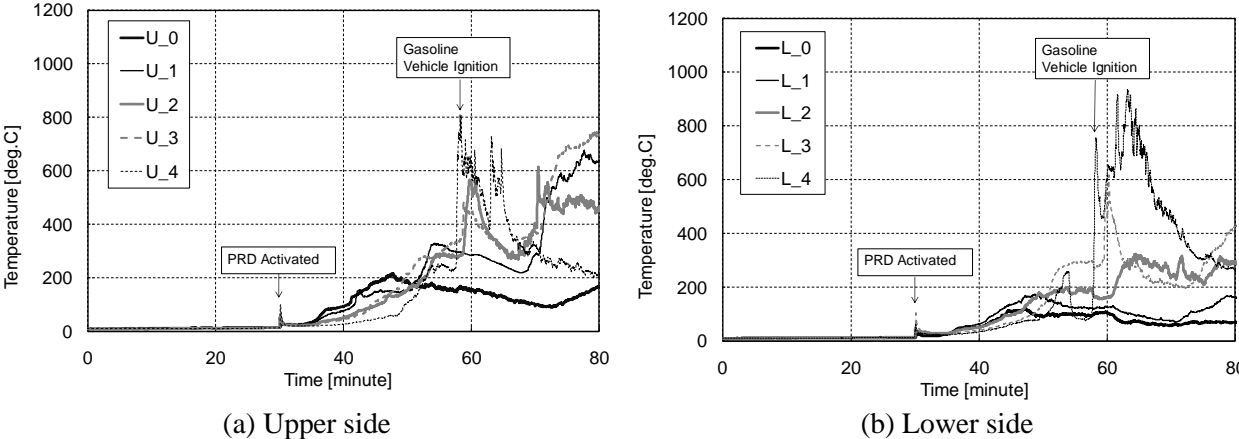
Figure 5. Temperatures on gasoline vehicle side

Temperatures on the gasoline vehicle's near side temporarily rose at time 30 min. or shortly after TPRD activation, with the highest temperature measured at 105°C at location L_1 which was closest to the vent pipe. Then the temperatures declined as the release of hydrogen gas completed. It was at time 34 min. that the temperatures resumed their climb. When temperature at location L_4 reached about 400°C, the gasoline vehicle caught fire. Fig. 6 shows the temperatures measured at Vent0, 1, 2, 3 and 5 all 1 cm above ground.

The gasoline vehicle caught fire at time 57 min. 26 sec. or roughly 28 min. after the TPRD activation of HFCV. Ignition of the gasoline vehicle occurred around the front tire on the near side of the HFCV. At this point the HFCV had already been burned down. Fig. 5 shows the temperature change on the side surface (see Fig.3) of the gasoline vehicle.

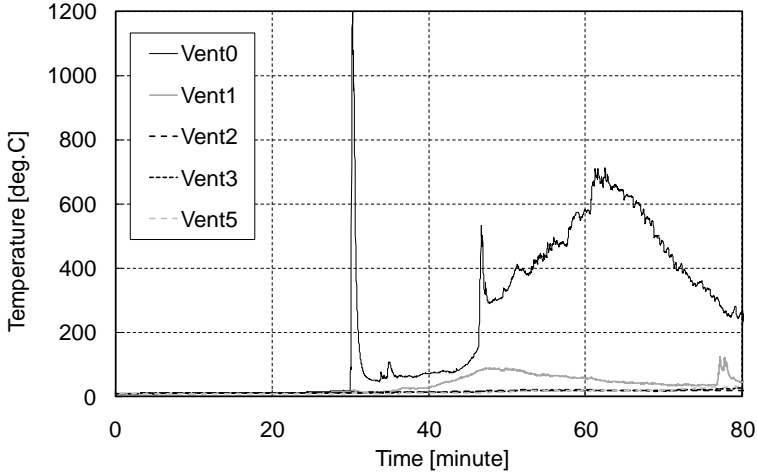
Figure 6. Temperatures at 1cm above ground

Although temperature under the vent pipe (Vent0) measured over 1,200°C at the time of TPRD activation (time 30 min.), temperatures under the gasoline vehicle's floor (Vent1,2,3,5) hardly increased during the initial 30 min. period. Similarly, temperatures around the gasoline vehicle's fuel tank did not notably rise at the time of TPRD activation. This is because, as shown in Fig. 7, the underfloor flames curled up on both sides of the HFCV's body so that it was not possible for the flames to spread across the 0.85m separation into the underfloor space of the adjacent vehicle.

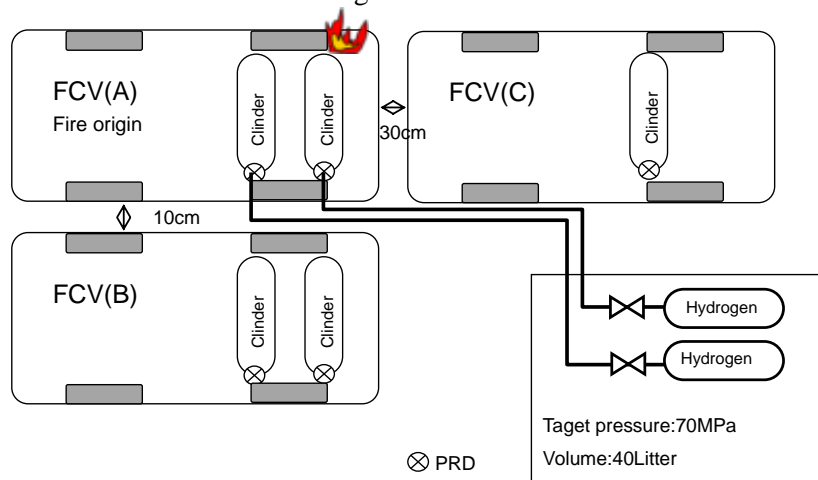
Figure 8. Schematic of test-2 setup

Employed were three test vehicles: HFCV-A which was the fire origin, HFCV-B on the lateral side of HFCV-A, and HFCV-C on the rear side. Following the regular practice in car carrier ships, the test vehicles were parked with a 10 cm lateral and a 30 cm longitudinal separation. The test vehicles were basically gasoline vehicles with their fuel tanks and mufflers replaced with those of HFCV. HFCV-A and HFCV-B respectively had two simulated tanks forward and rearward to the rear axle under the floor, while HFCV-C had only one tank forward to the rear axle. Each of the simulated tanks was made of steel and measured 318 mm in diameter and 800 mm in length with a storage capacity of 40L or more.

The setup of this test was as schematized in Fig. 8.

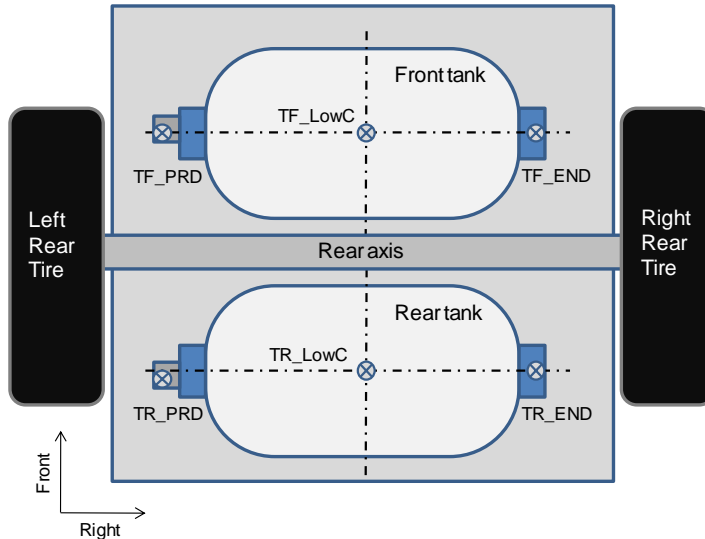
Fig. 12 shows the locations of temperature measurement points on hydrogen tanks as viewed from the ground. For data compilation purposes, abbreviations were used. For example, "BTF" means the front tank of HFCV-B and "LowC" means the lower center of a tank.

Fig.12 Temperature measurement points on tanks

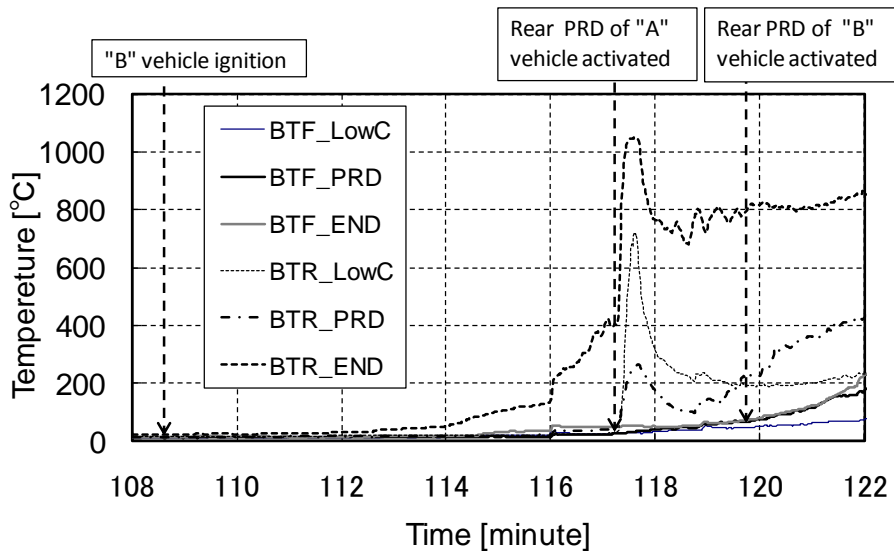
Fig. 13 shows the temperatures measured around HFCV-B during the interval period from its ignition to rear TPRD activation.

Figure 13. Temperatures on HFCV-B's tanks

After the ignition of HFCV-B, temperature at its rear tank's end plug (BTR_END) gradually increased, and about 117 min. later the temperatures all over the rear tank climbed rapidly, following the activation of HFCV-A's rear TPRD. About 3 min. after this temperature climb, the rear TPRD of HFCV-B activated; however, HFCV-B's front tank was hardly affected by the TPRD activation in HFCV-A.

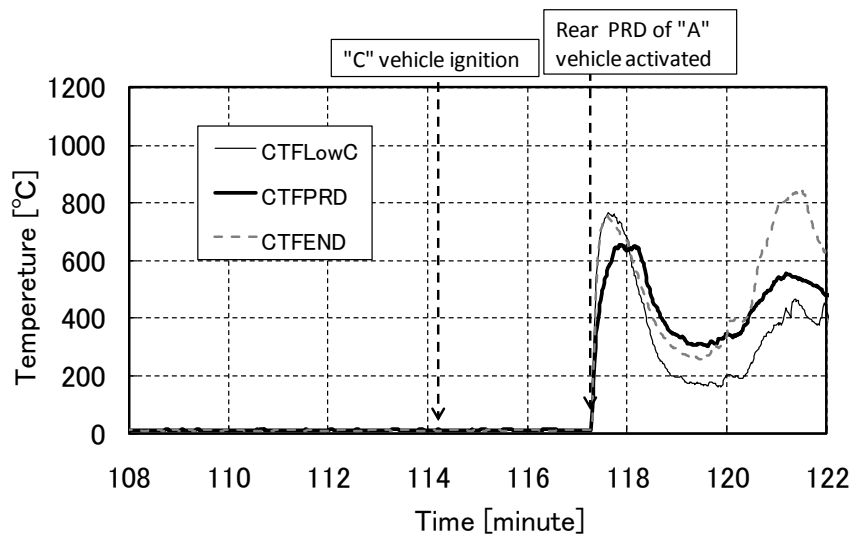
Figure 14 shows temperatures on the front tank of HFCV-C which was parked behind HFCV-A, when the rear TPRD of HFCV-A activated.

Figure14. Temperatures on HFCV-C's rear tank

Although temperatures on the front tank did not change for some time after HFCV-C's ignition, the temperatures suddenly climbed after the activation of HFCV-A's rear TPRD. These results suggested that under the conditions of the present study, (1) adjoining vehicles are ignited by the flames spreading from the interior and exterior fittings of the fire origin HFCV; (2) subsequently the fire origin HFCV undergoes TPRD activation and thereby generates hydrogen flames, causing the underfloor temperatures of adjoining vehicles to go up and inducing their underfloor TPRD to also activate.
